The benefits of internal coating and other flue gas vessels

Combating Corrosion

Debra Ashley, Ashcoat, LLC, USA, presents a study based on corrosion attack to the interior kiln shell wall, and discusses the benefits of internal kiln coating applications.

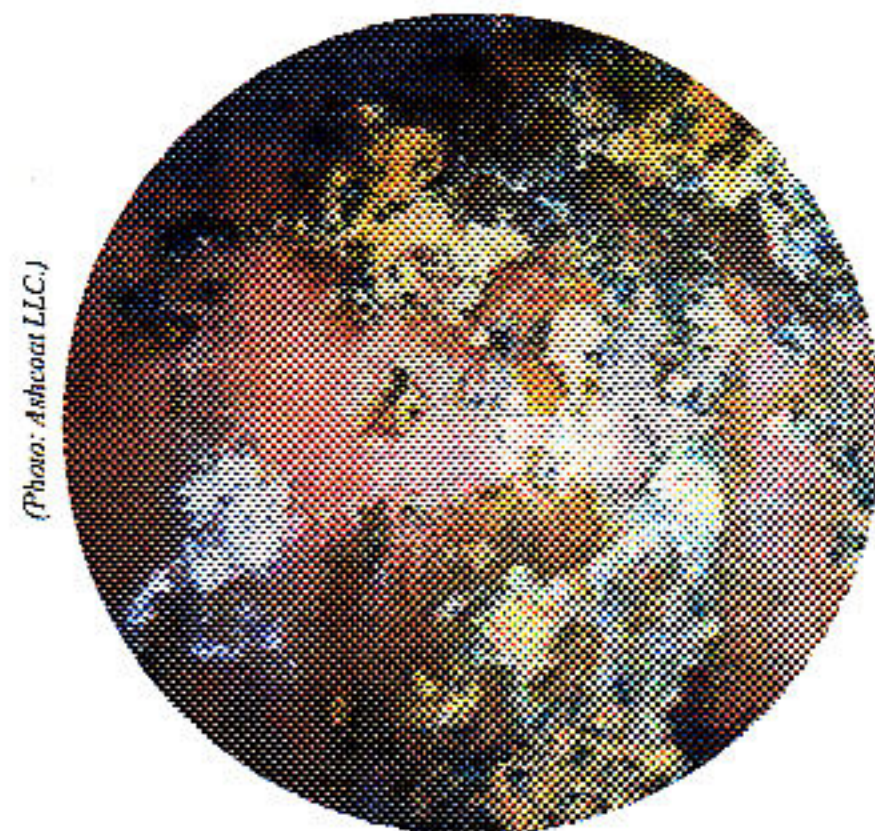
In March 2001, the company was presented with an interior kiln shell with a diameter of 6×4m. The area presented was located in the upper part of the kiln. The original estimated steel thickness ranged between approximately 111 to 254mm. Inspection took place following the removal of refractory brick from the area during plant outage. The appearance of the substrate surface revealed severe corrosion. Numerous areas of pitted steel and peeling delamination were found. The delamination appeared to be approximately 1.6mm thick (see Figure 1).

Figure 1: The example of severe corrosion was found on the untreated internal surface of a cement kiln.

The surface was abrasive blasted to a SSPC-10 near white blast with a profile of 0.025mm, as specified by the Steel Structures Painting Council⁽¹⁾. An application of aluminium-filled, silicone-based, heat- and corrosion-resistant coating was then spray-applied to the surface substrate at a dosage of 4.0 wet mils thickness, which would dry at 1.5 dry mils thickness. The coating was aqueous-based volatile organic compound (VOC) compliant and would be dry to touch and handle within two hours after application, prior to installation of new refractory bricks. Full curing would occur when plant went back into service. This full procedure was performed within one eight-hour shift.

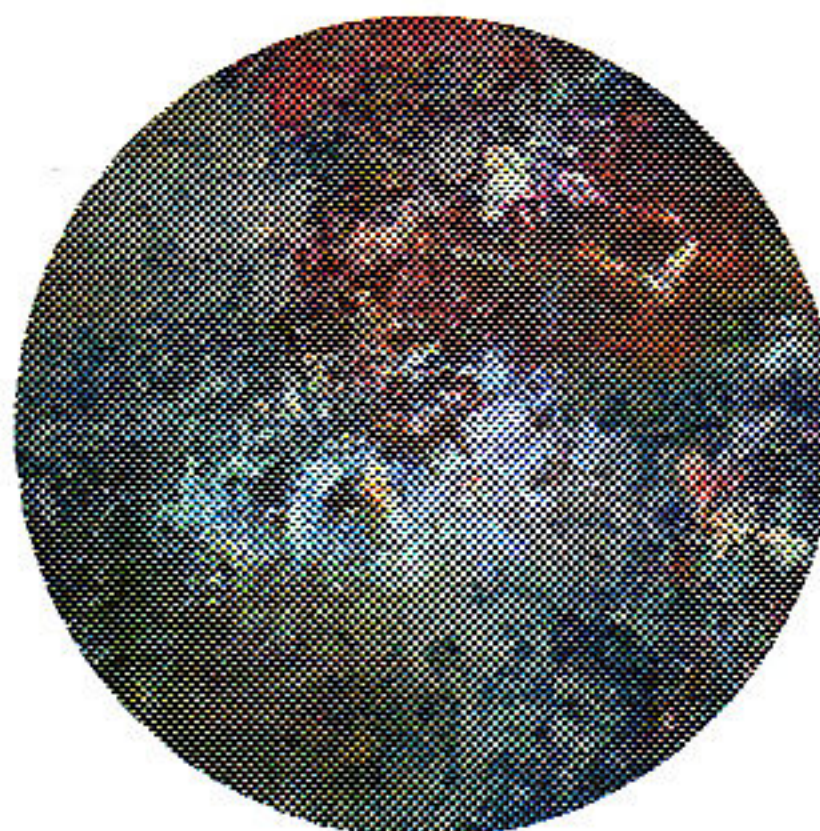
In March 2002, the company was presented with a different portion of interior kiln shell wall with the same area. It would have had the same original shell thickness and was experiencing the same type of deterioration. The company was also allowed to investigate part of the steel that had been coated one year previously and no further delamination of steel thickness was found. The coating was still evident on much of the surface and the substrate appeared smooth, with no evidence of deterioration (see Figure 2).

Figure 2: The kiln wall coating one year after application.

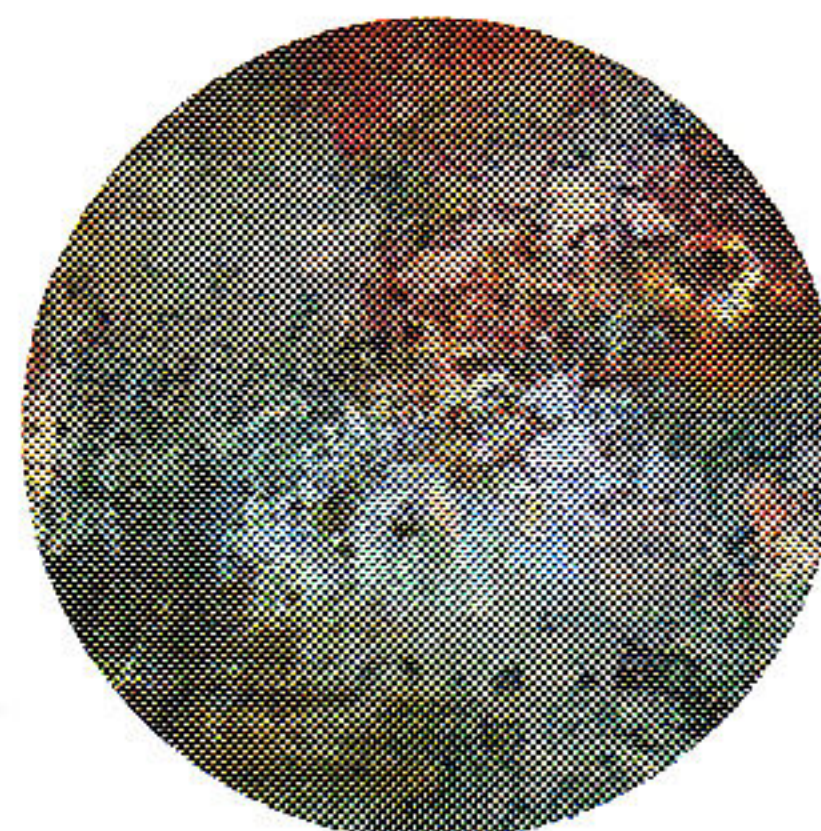
Figure 3: The kiln wall three years after application.

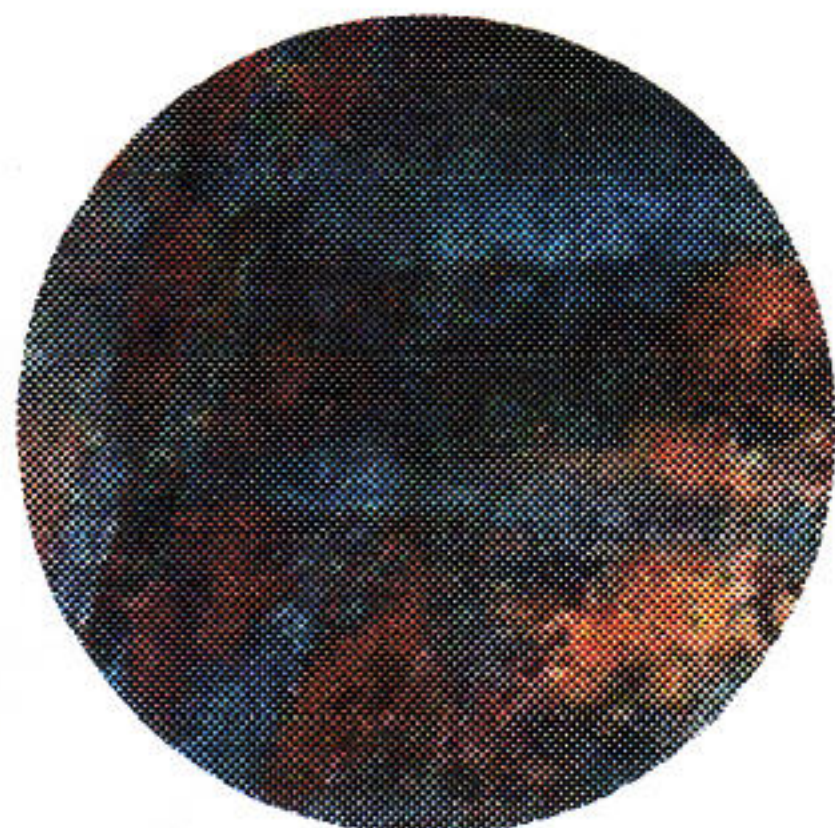
Figure 4: The same wall four years after application.

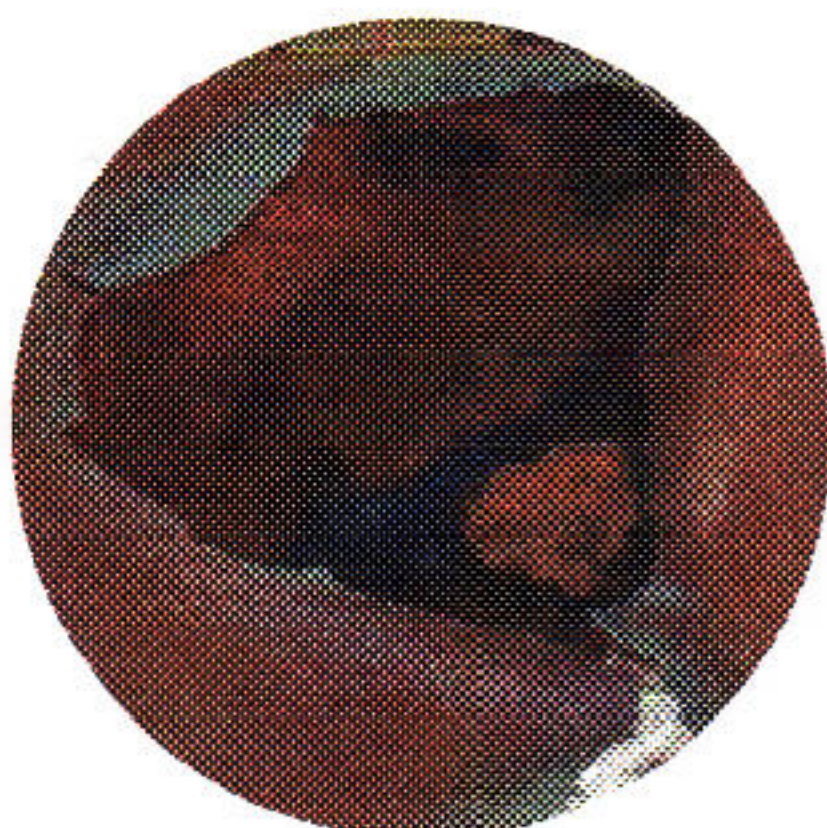
There is a main flare stack of the preheating tower in most cement plants. Gases derived from the by-products burned in the kilns are expelled through this stack and are thus exposed to an aggressive environment akin to that of the kiln. Figure 5 shows how a flare stack interior has corroded. The stack was approximately 57m tall with a diameter ranging from 4-6m. This was exposed to a similar environment, but heat exposure was not as great as that of the kiln. The operating temperature of the stack is approximately 140°C, but once a week the temperature would rise to approximately 180°C. The degree of corrosion varied at different heights within the stack, thereby indicating that exposure to moisture and chemical attack is greater in those areas.

Figure 5: Advanced corrosion on the internal wall of a flare stack.

The substrate was abrasively blasted to an SSPC-10 near-white blast profile of 0.025mm. A high-performance

silicone-based coating was spray-applied to a prepared surface at approximately 7 wet mils per coat which would dry at 4-5dft (dry film thickness) per coat. Three coats were applied to achieve a total dry film thickness of 14-15dft. Research will be undertaken the status and condition of the coating in the future (see Figure 6).

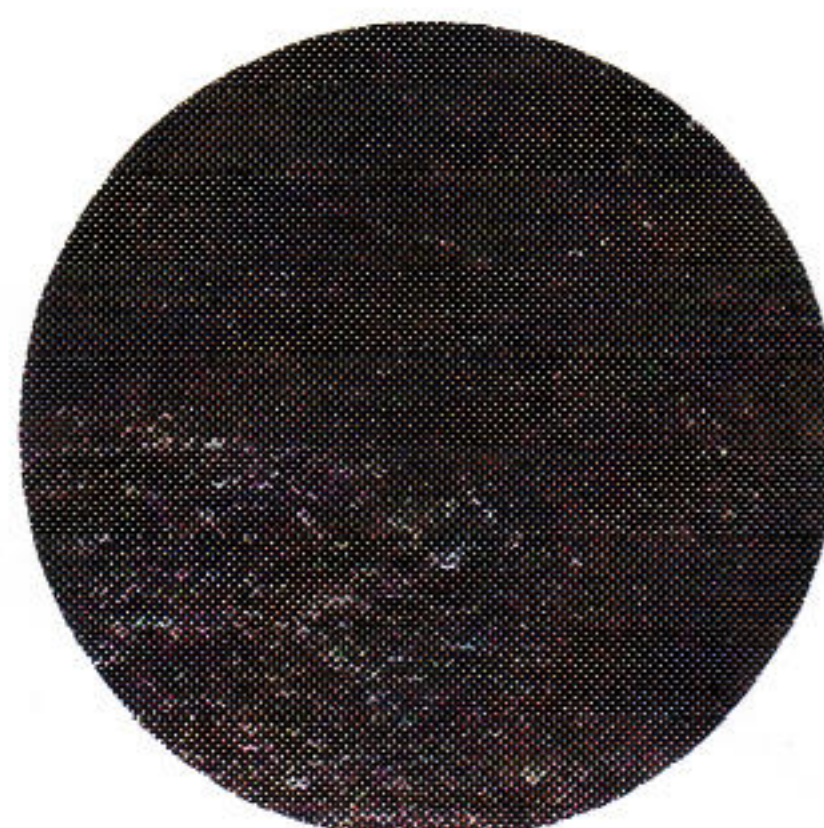
Figure 6: The coating applied to the internal wall of a flare stack.

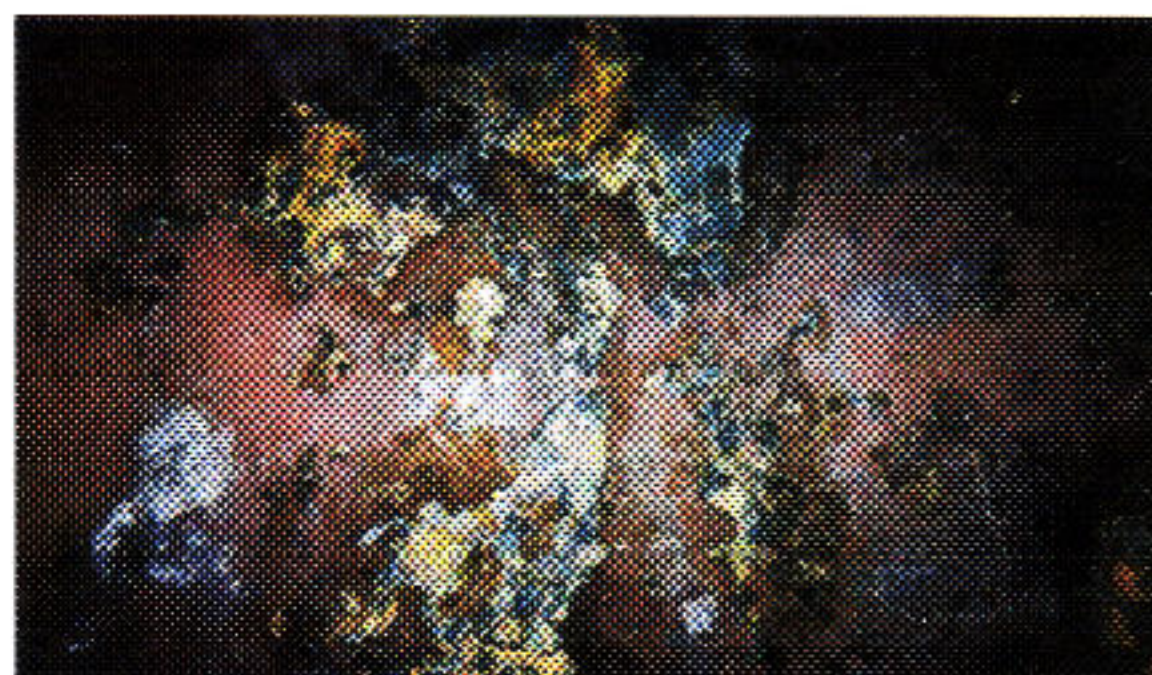
In March 2001, the study began with a surface preparation and test coating application of approximately 20 ft x 13 ft 6 in. dia. of interior kiln shell. The area was located in the upper transition of the kiln. The original estimated thickness of steel was approximately 7/16th in. to 1 in. The inspection of this area took place during normal plant outage following the removal of refractory brick. The appearance of the surface of the substrate revealed severe corrosion. Numerous areas of pitted steel and an orange peel type of delamination of steel was also sighted (Figure 1). The thickness of delamination appeared to be approximately 1/16th in.

Figure 1. Uncoated surface kiln wall.

The surface was abrasive blasted to a SSPC-10, near white blast (0.001 in. profile). An application of a heat and corrosion resistant coating was applied. This coating was a binding system of an aluminum filled, silicone-ceramic aqueous based material. The coating was applied by conventional spray method to surface substrate at 4.0 mils wft (wet film thickness) and would dry at approximately 1.5 mils dft (dry film thickness) per coat. The full procedure was performed within one eight hour shift. The coating was dry to touch and handle within two hours after application, thus allowing refractory personnel re-entry to complete installation of the new refractory without undue delay. Full cure occurred when the plant went back into service.

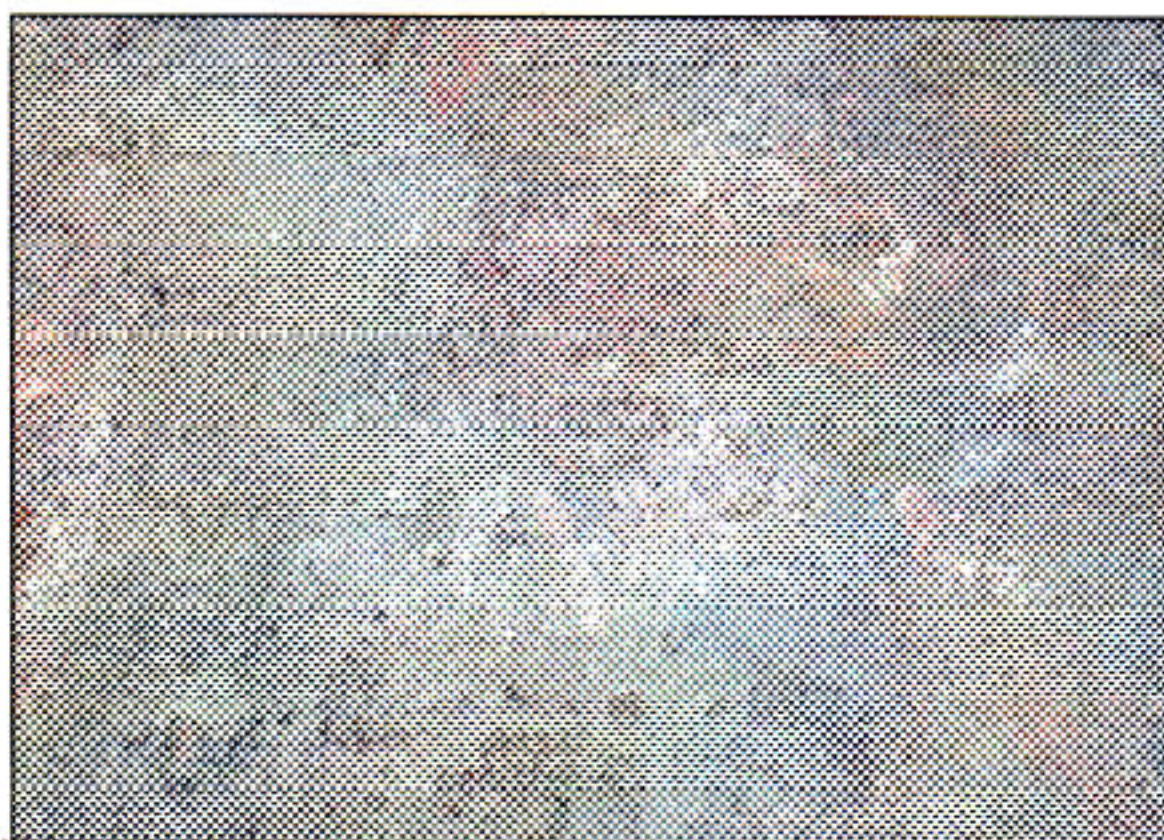
Figure 2. Inspection of 2001 coating one year after application.

At this time, Ashcoat was allowed to inspect an area from the first application of March 2001. The inspection revealed no delamination of steel thickness, and the coating could still be seen intact in much of the surface. This result appeared to be a significant success, as there was no evidence of steel density loss, and the coating still seemed intact, which was more than had been hoped for at that time (Figure 2).

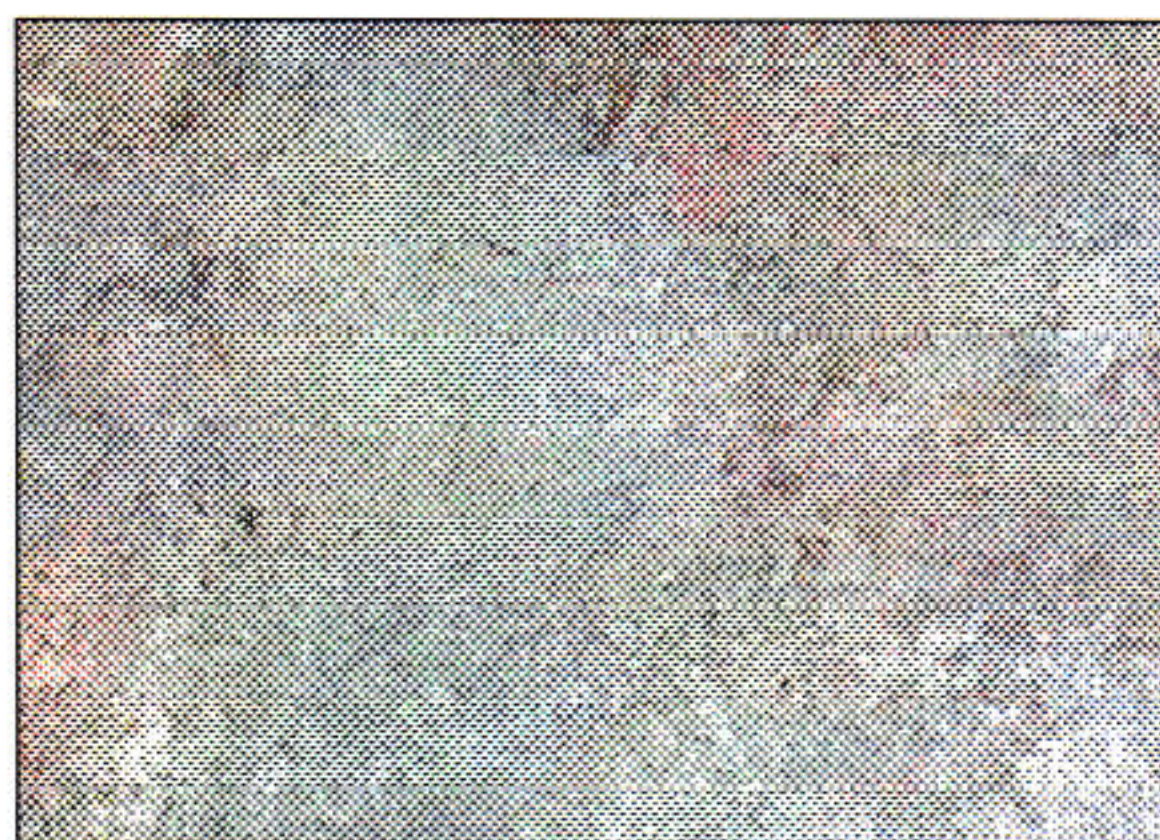
Figure 4. Inspection of 2002 coating two years after application.

The substrate was washed and cleaned of surface rust and pollutants before the inspection and photographs were taken. On examination, much of the coating remained intact with significantly smoother surface to coated areas than the uncoated areas of the same piece of kiln shell.

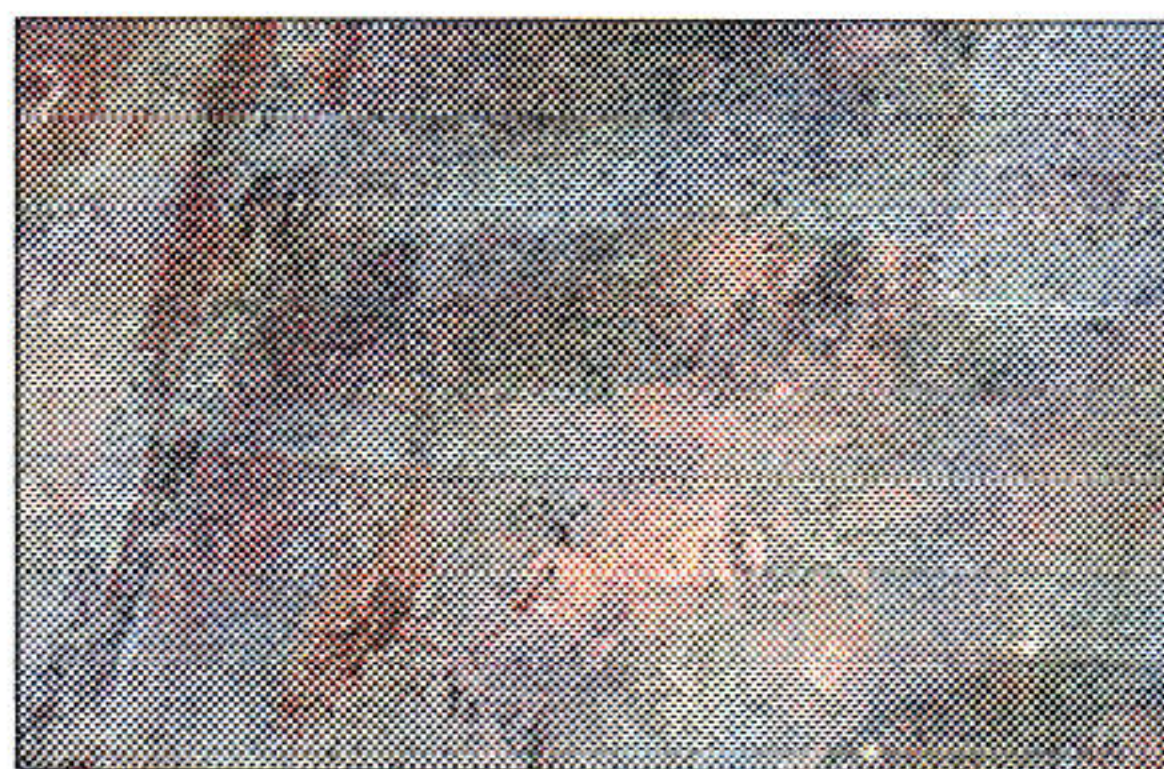
Figure 3 illustrates the area which was washed and cleaned of surface rust and pollutants to expose steel substrate. This not only shows some areas of coating remaining intact, but a smooth surface to those areas with no significant evidence of delamination or pitting compared to the original inspection, and indicates that the coating created a barrier between the contaminants and substrate.

Figure 3. Inspection of 2001 coating three years after application.

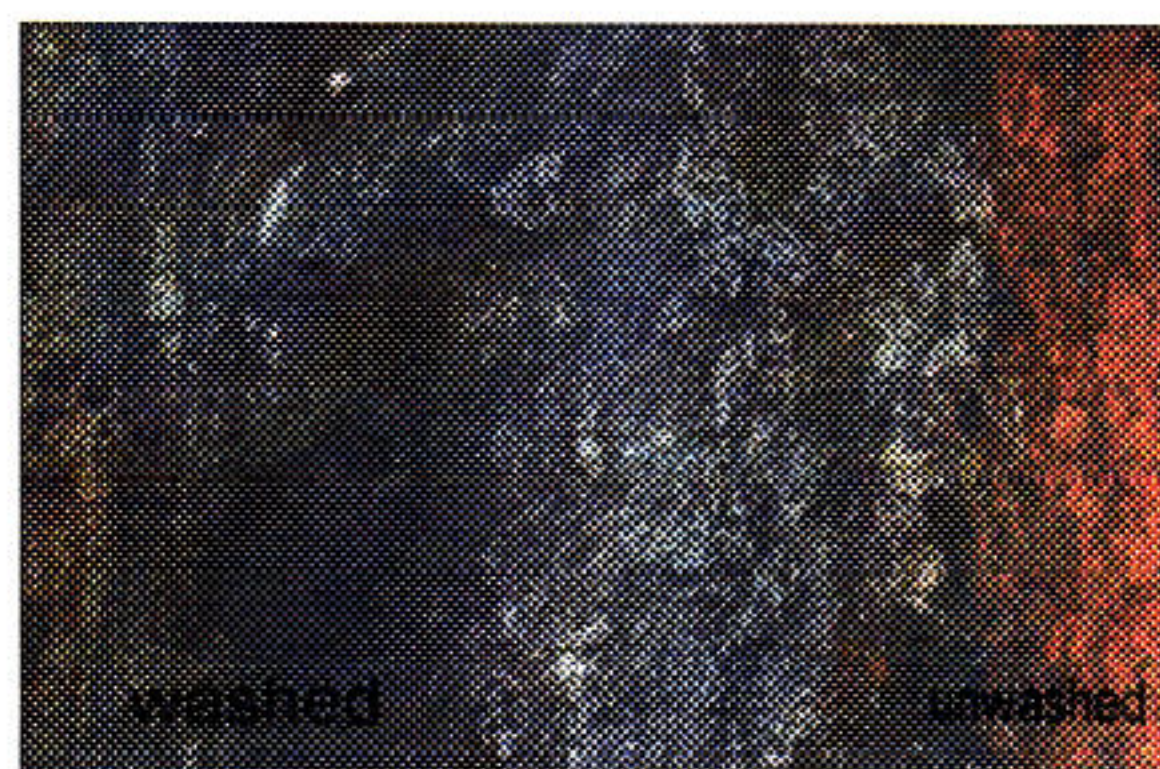
The substrate was washed and cleaned of surface rust and pollutants. An inspection one year after the application revealed the existing coating to appear intact with a significantly smoother surface to coated areas than the uncoated areas of the same piece of kiln shell (Figure 5).

Figure 5. Inspection of April 2003 application after one year.
